**Robust Project.**

**Deliverables D.3.4**

**New lightweight mounting block.**

**Natural frequencies measure**

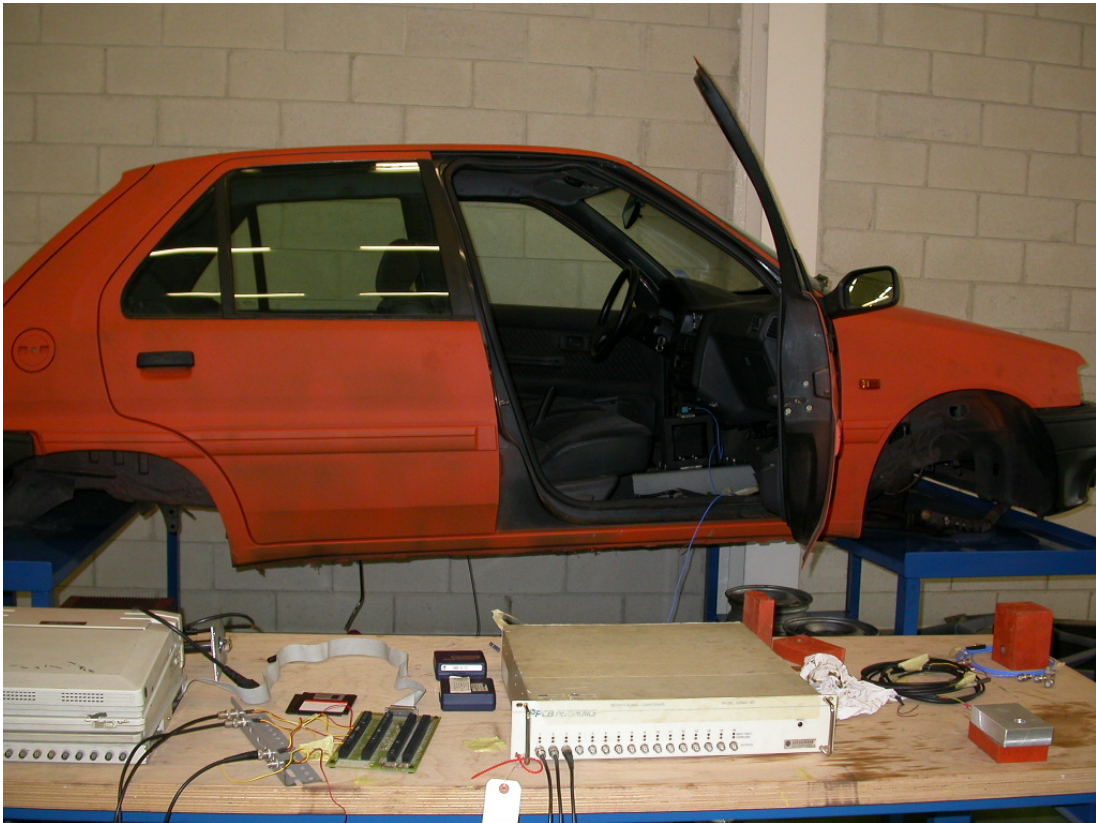
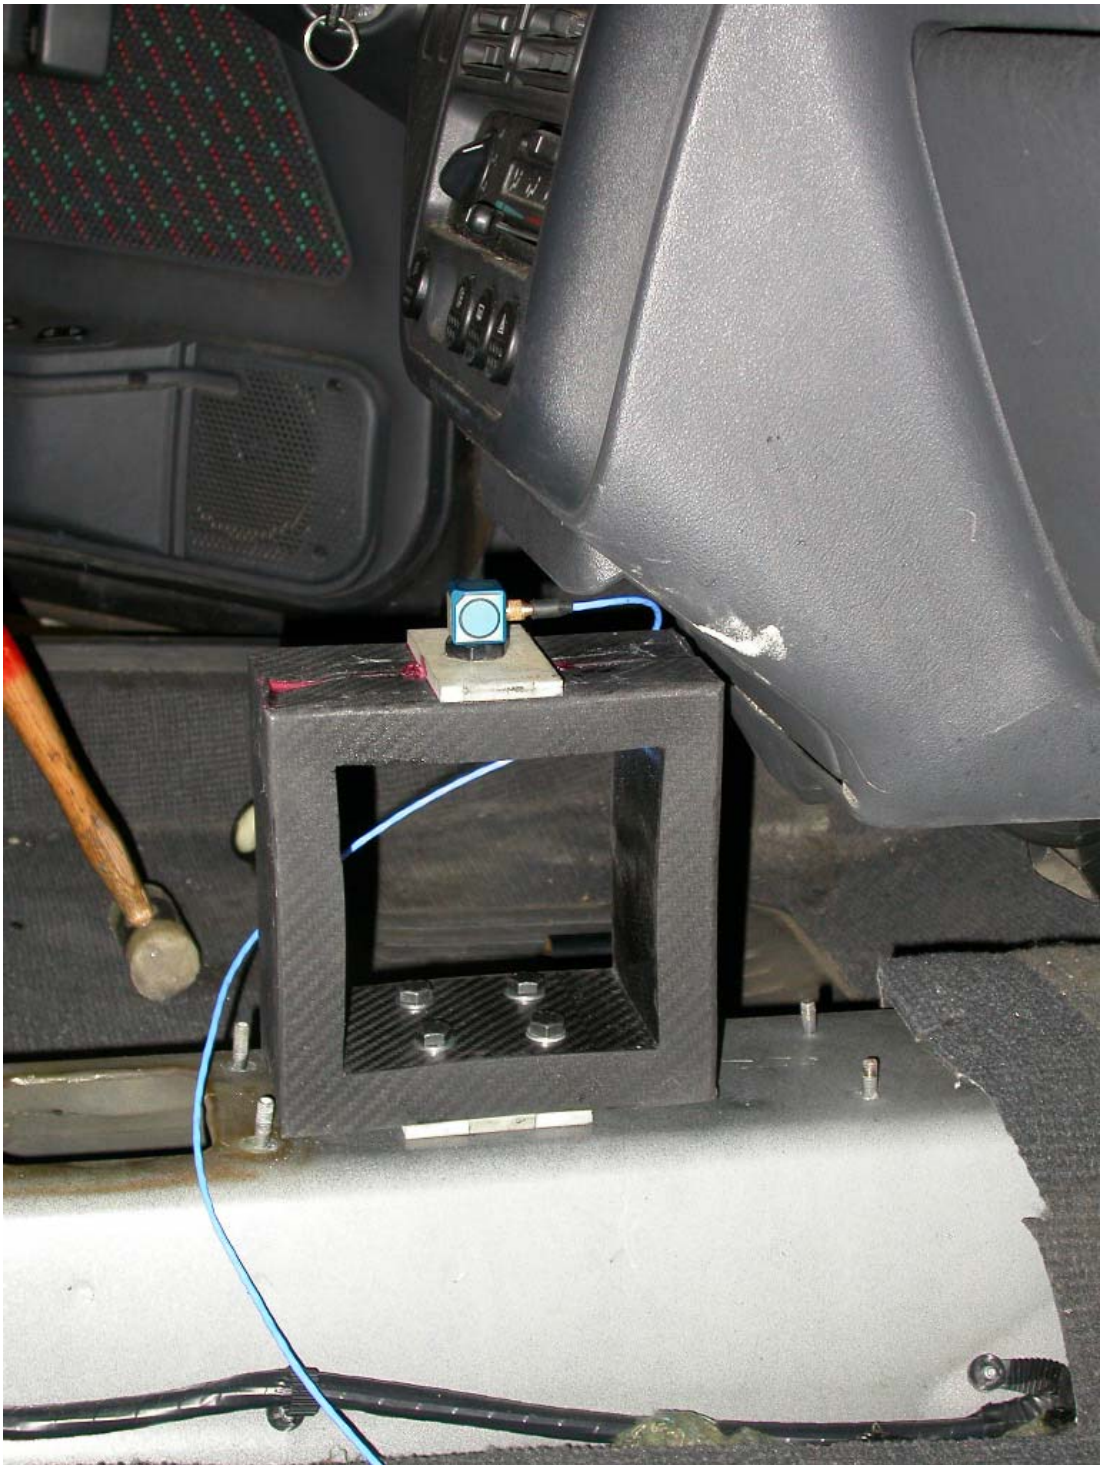
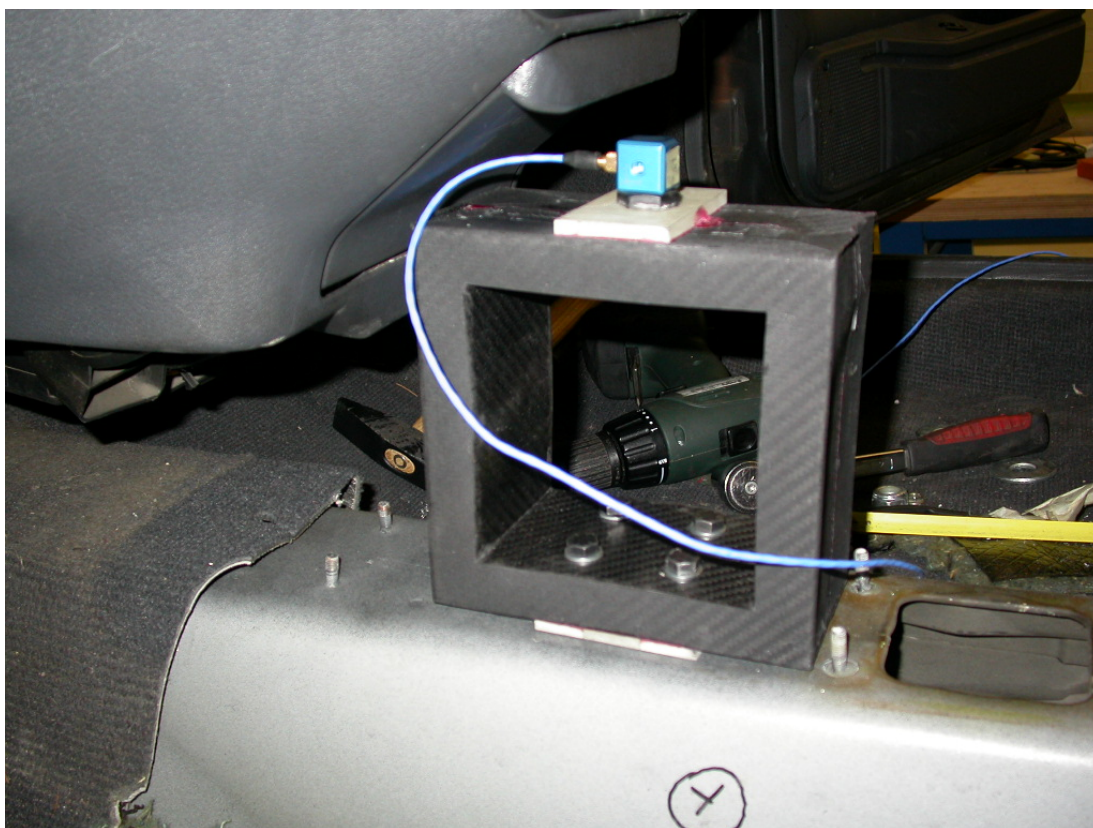
*Figure 1: Test procedure*

Figure 2 Test procedure

Figure 3 Test procedure

A first series of tests have been conducted using the installation procedures agreed by the consortium. The structure has been fixed on the tunnel of the vehicle using 4 bolts (8 mm diameter). To measure the frequency behaviour a standard technique for modal analysis has been adopted impacting the structure with a small hammer and measuring the output with piezoelectric accelerometers with high sensitivity.

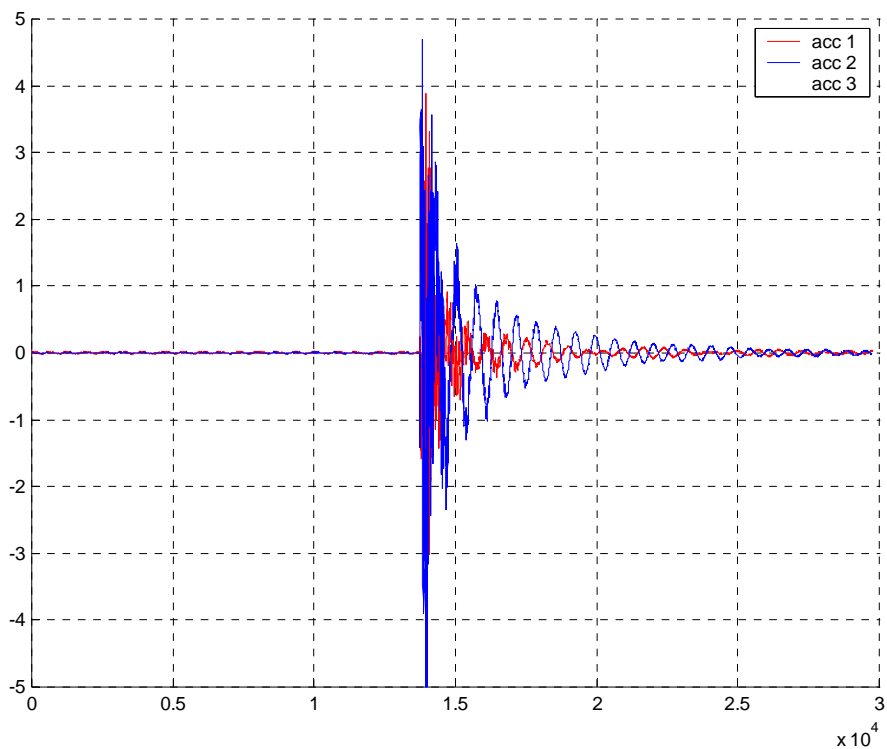
Figure 4: Accelerometer time history.

During these tests a triaxial accelerometer has been installed on the structure. The output of these accelerometers, together with the spectrum response showed a behaviour similar to the one seen at TRL even if the main frequency is here at about 85 hz. The difference between this frequency and the one measured at TRL (50 hz) is probably due to the different placement of the structure and the presence, at TRL, of the heavy structure used to release the cable that lowers all the natural frequency increasing the mass of the adjacent structure.

This figure shows these important results:

1. The behaviour shown during TRL tests has been reproduced even if the resonance frequency is at 85 hz
2. This is the only frequency present and if we are able to shift this frequency where severity indices don't work all the possible concerns related with these oscillation are removed.

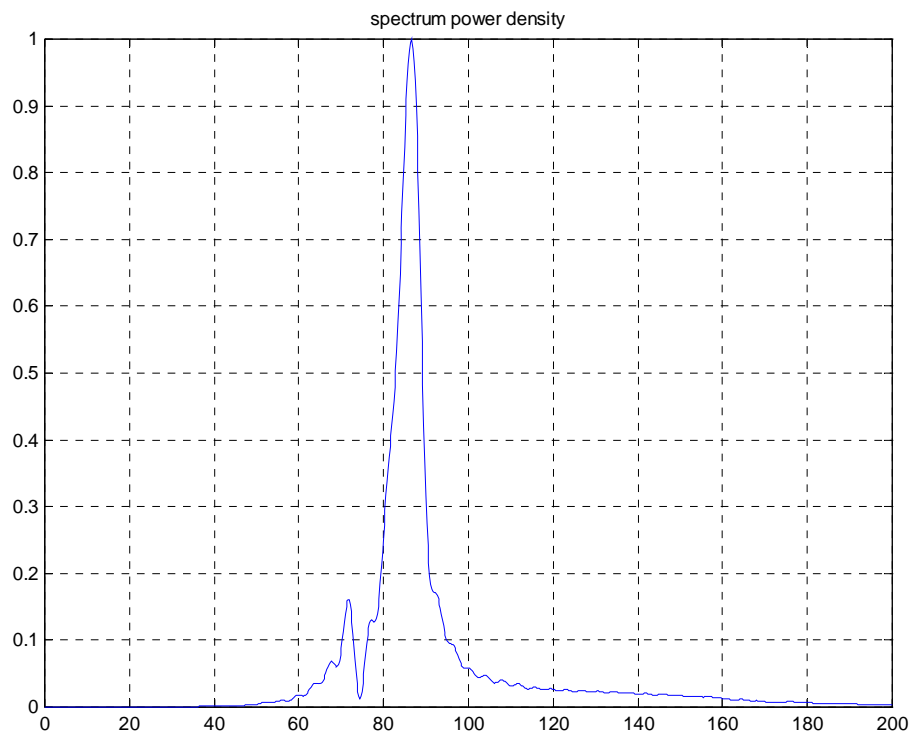
Figure 5: spectrum x direction

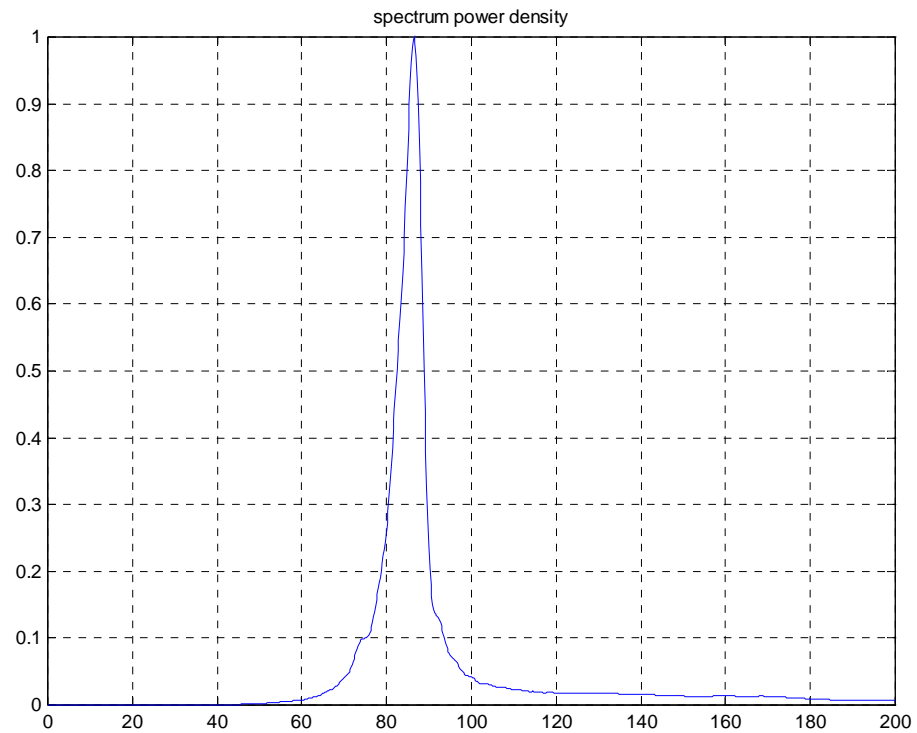
Figure 6: spectrum y direction

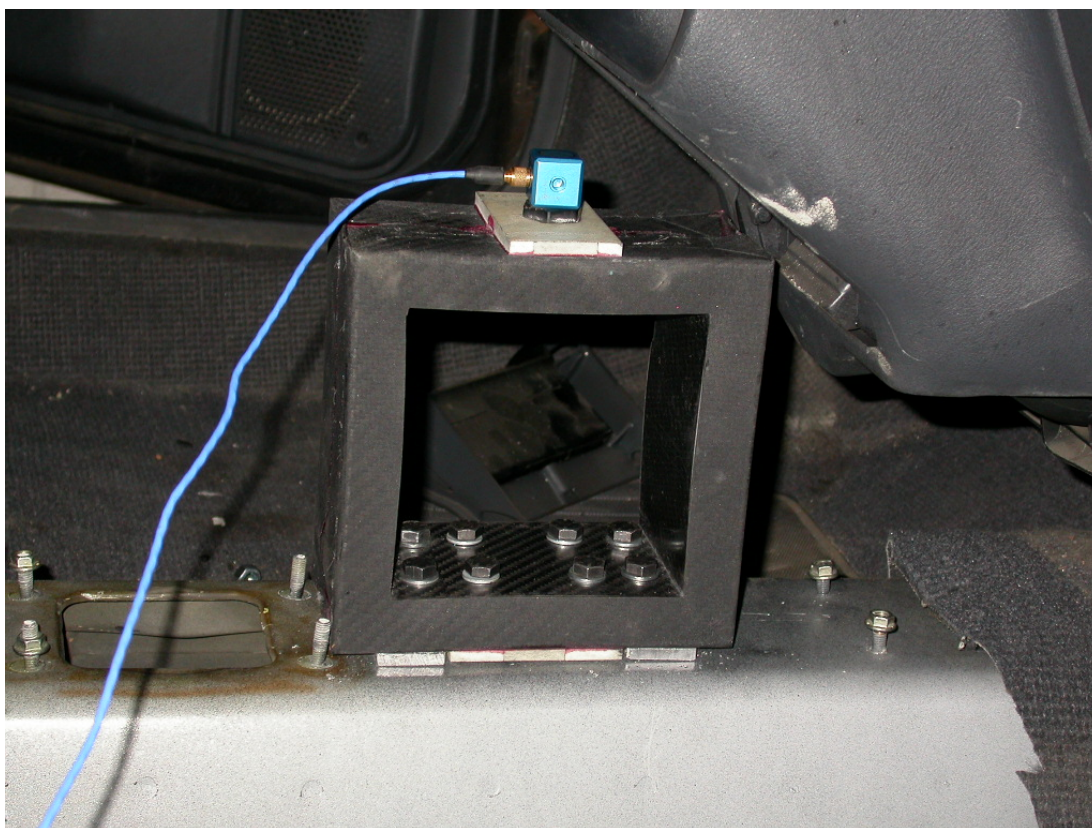
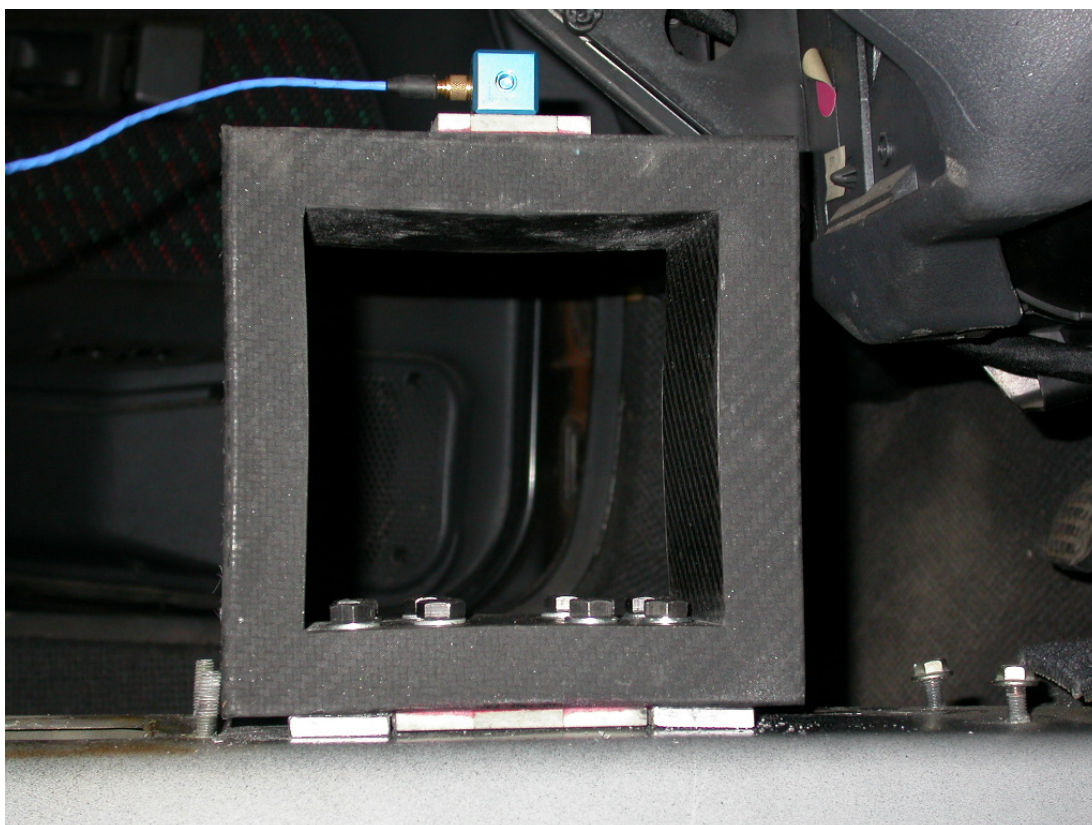
*Figure 7 New mouting*

*Figure 8 New mounting*

To overcome the above shown problem we simply added four more bolts and introduced spacers to fix the structure on a wider part of the floor. In the following photos this new fixture is shown

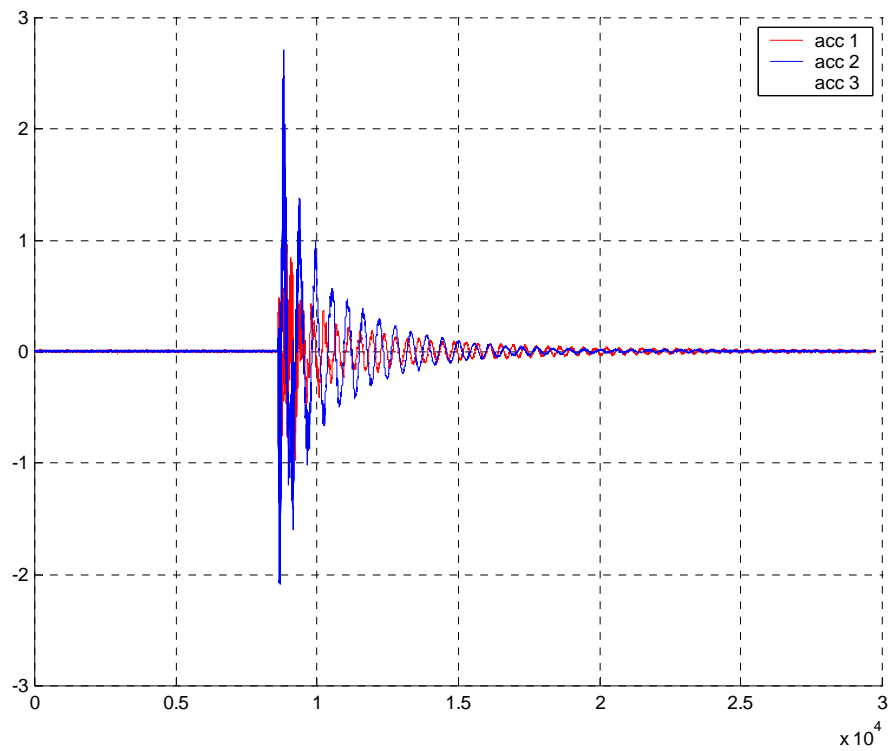
*Figure 9:8 bolts accelerometers time history*

These results show that this modification strongly modify the frequency response.

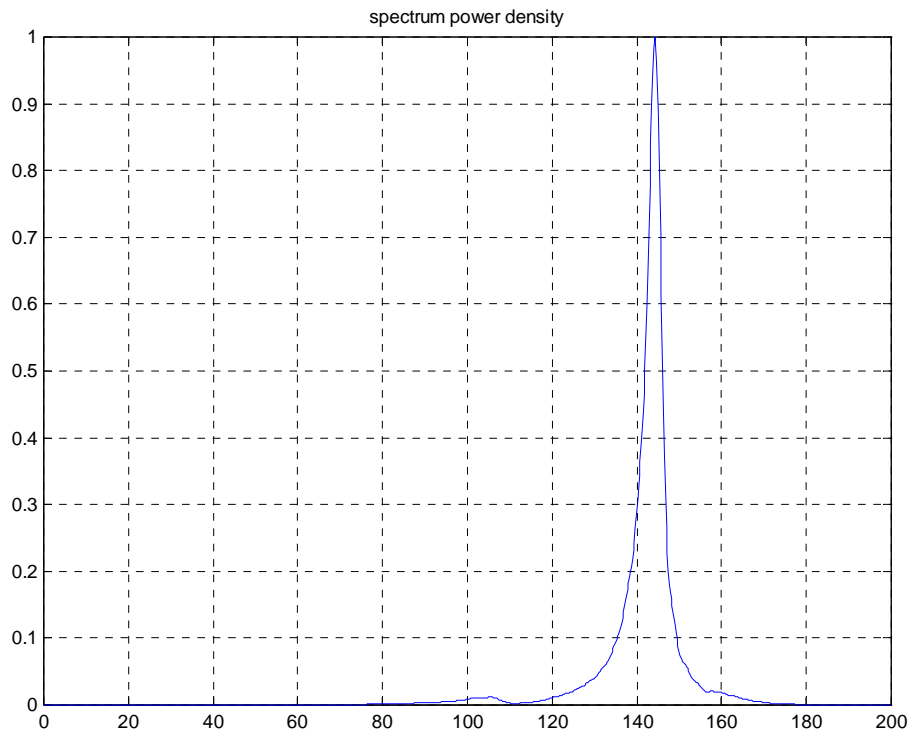
Figure 10 Spectrum x direction

With this modification the first natural frequency of the system is above 105 hz (y direction) ad 140 Hz (x direction) . These frequencies are far from the relevant for the severity indices evaluation. Further tests will be performed using also the metal plate between the carbon fiber and the bolts.

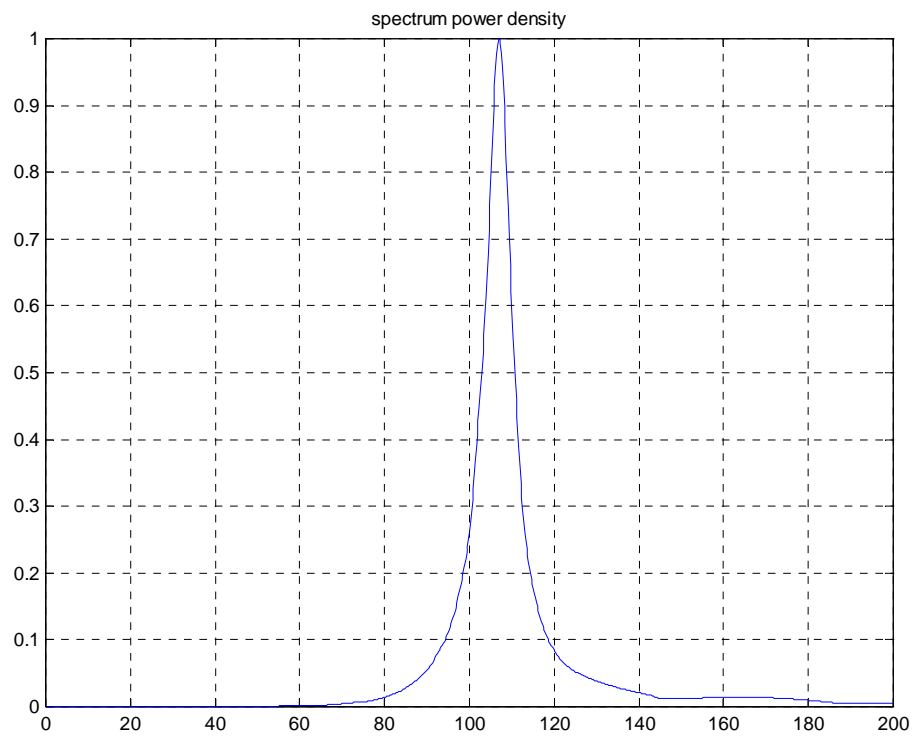
Figure 11 Spectrum y direction
